6/8/2020 Update by Tova Plaut

# BABY POOL

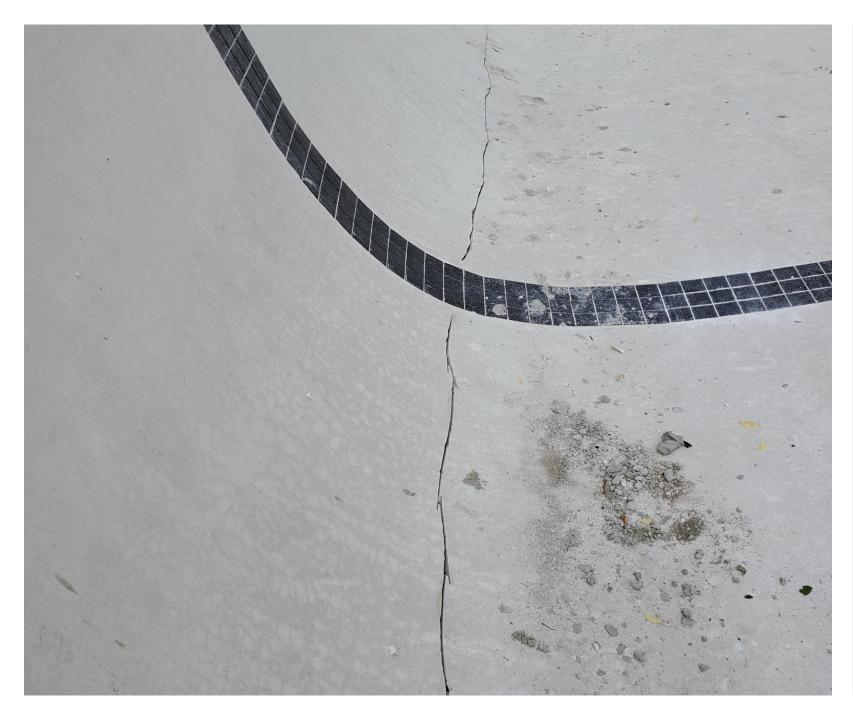
### Cracks

Foundational Cracks along base of large pool was causing leakage and disrupting the integrity of the pool walls and floors.

Without immediate repair, the pool would have needed a full replacement in the near future.

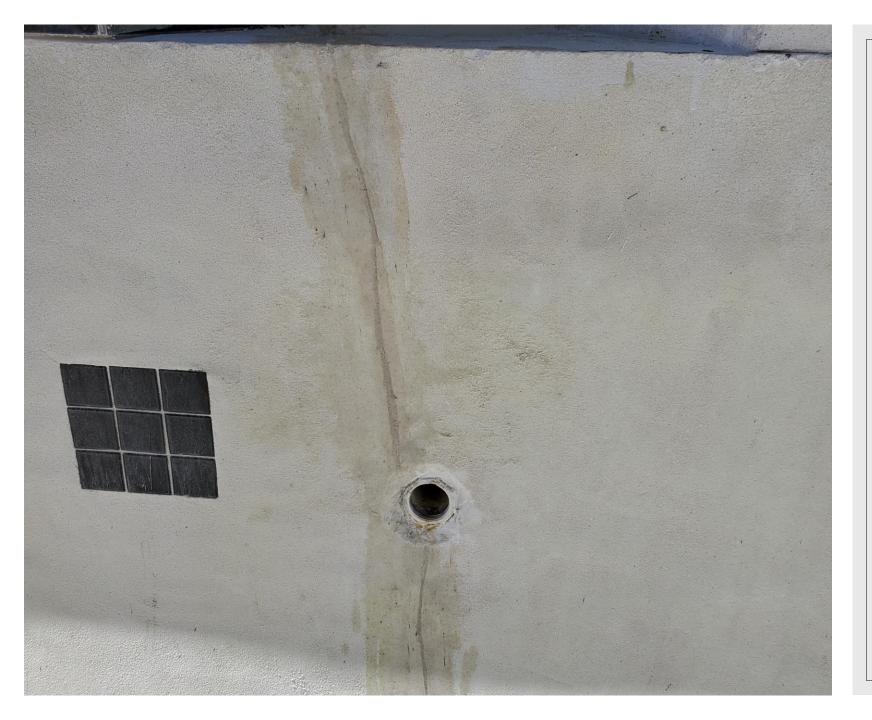
### Foundational Crack

Additional foundational cracks in the Main Pool were found in the side walls. The crack shown in this picture after repairs was the most dangerous of the many cracks found. The integrity of the side wall was already severely damaged. Immediate repairs and reinforcement was necessary.

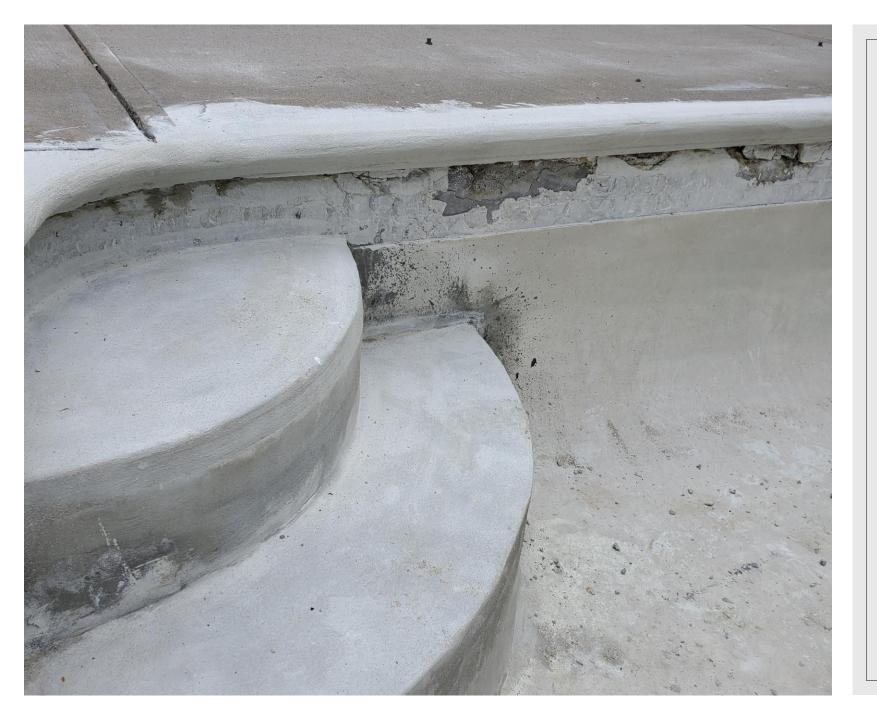
### New stairs

Guppy Pool

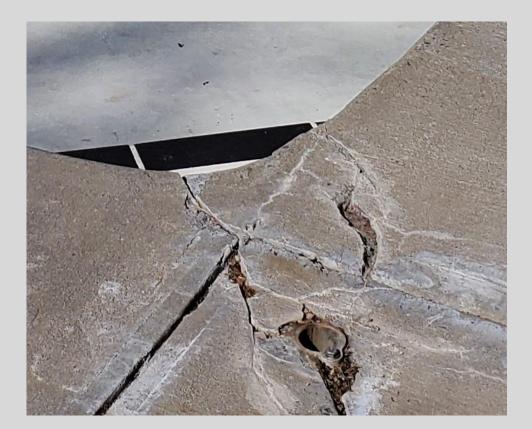
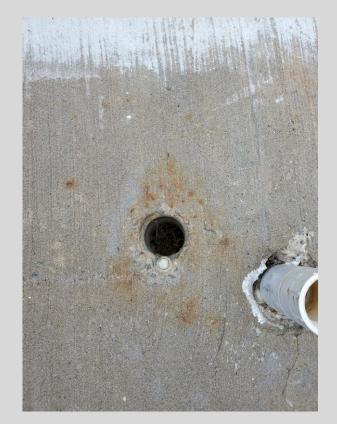
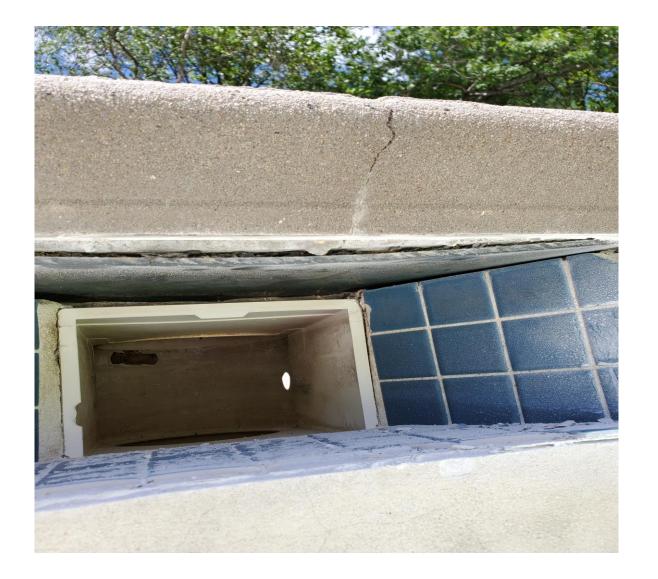
### Deck and Tile

Old Coping and Tile Cracked and damaged Rough texture Sharp edges
